RAHWAY RIVER BASIN
LAMBERT'S RUN, UNION COUNTY
NEW JERSEY

SHACKAMAXON DAM NJ 00369

PHASE 1 INSPECTION REPORT NATIONAL DAM SAFETY PROGRAM.

Richard J. McDermott

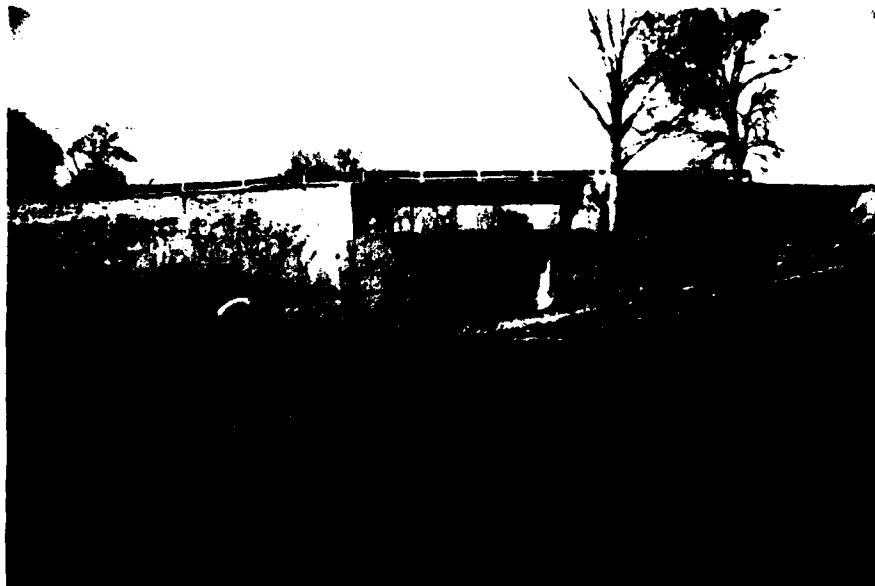
PHOTO 1
SPILLWAY

The downstream side of the spillway appeared to be founded on red shale bedrock. The core of the spillway is reported to be earthfill, and the surface is grouted rubble walls for both the upstream and downstream side. The crest had a low section at the left end where most of the water was overflowing. The concrete surfaces appeared rough, irregular and of substandard quality workmanship. Deterioration was observed at the toe of the spillway where reinforcement was exposed.

VISUAL EXAMINATION OF	OBSERVATIONS	REMARKS OR RECOMMENDATIONS
WEIR	Concrete weir with trapezoidal section. Concrete surface appeared rough, irregular and of substandard quality workmanship.	
TRAINING WALLS	Training walls, which also serve as bridge abutments appeared to be in good condition and of satisfactory workmanship.	
DOWNSTREAM FACE	Surface formed from grouted cobbles laid flush with existing concrete piers - appeared to be rough, irregular and of substandard workmanship. Exposed steel at toe could be reinforcing rods.	
DISCHARGE CHANNEL	Spillway discharges directly into downstream channel.	
BRIDGE	Steel beams, timber roadway and timber guide rail appeared to be in good condition.

- 4) The spillway should be thoroughly inspected with the lake drawn down and any necessary repairs to deteriorated portions should be made.
- 5) The outlet works discharge channel should be lined with riprap or otherwise properly protected against erosion.

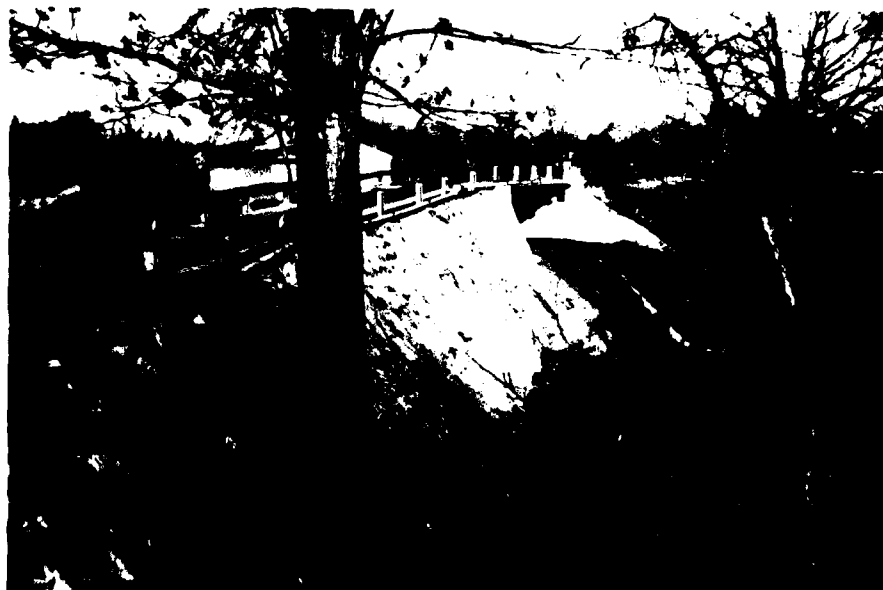
PHOTO 7

The upstream face of the embankment and downstream face of the south section of embankment were covered with a good stand of grass with some trees and brush noted. Trees and brush and rubble consisting of rocks and large pieces of concrete were noted at the toe of the south section of the embankment. Discharge of less than 1 gallon per minute was observed flowing at the toe from within the rubble. It could not be determined whether the discharge originated in the toe drain or was due to uncontrolled seepage.

DOWNSTREAM FACE OF DAM - SOUTH SECTION

- 1) Adverse vegetation should be removed from the embankment.
- 2) Concrete rubble should be removed from the toe area and the area properly graded and protected with a suitable ground cover.
- 3) With the concrete rubble removed, the observed discharge at the dam toe should be investigated to determine whether it is due to normal toe drain function or to uncontrolled seepage. If due to uncontrolled seepage, appropriate remedial measures should be taken to control or eliminate the seepage.
